Looting and Archaeological Destruction of the Northern Heritage sites in Kharga Oasis

Abstract

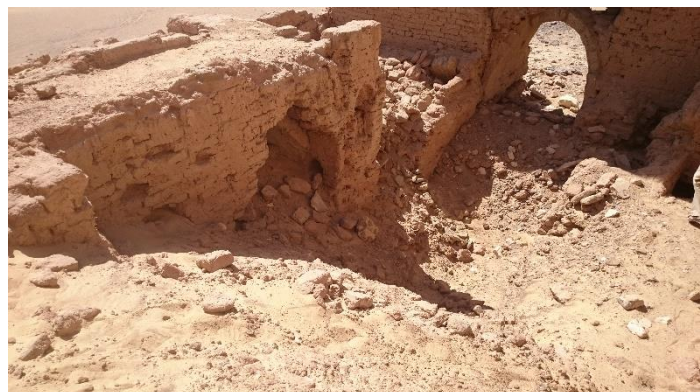
In 2011, opportunistic looters demolished the inner western side of the second floor trying to find any treasure behind it. The same thing was reiterated in 2015 but the damage this time was behind the inner side of the Southern gate (Fig 3). In 2012, the robbers dug in the area to the north of the fort searching on the ancient treasures. This excavation

Fig 3. The inner destruction behind the southern gate, Ain Gib. Photo by the author (2024)

revealed a square ancient shaft cut into the bedrock, it was filled with sand. It seems likely that this part might have been used as a tomb. This is support by the human bones and skull found there (Rossi & Ikram, 2018, p.50).

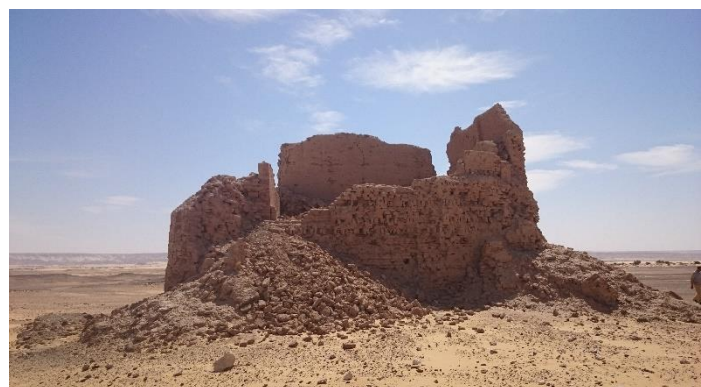
According to the description of Gascou, Wagner, and Grossmann who visited the site in 1979, the fort of Ain Sumayra had three stories: the ground floor and two upper floors. 23 years later, during the first site survey by the NKOS (2001), the archaeologists found only two floors. The third floor has disappeared, most likely destroyed on the hands of the local inhabitants who look for the ancient treasures or

Fig 4. The piles of mudbricks that brought out of the fort by the robbers. Photo by the author (2024)

even used the mudbricks of the ancient buildings in other constructions or for the cultivation activities. Sadly, the violation of the site did not stop there. The report of the second season of the NKOS on the site says: “Someone removed tons of loose mudbricks from the fort and threw them outside the East face” (Fig 4) (Ikram et al., 2014, p.77; Rossi et al., 2022, pp. 743-744)

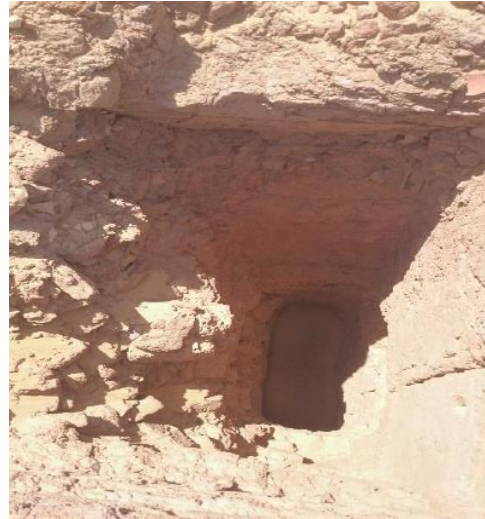
The robbers of antiquities represent the worst risks on this site, they deteriorated different places on the sites especially in the area of the cemetery. Their illegal activities on the site appeared clearly in deep holes scattered throughout the site. One of the worst violations by the robbers in the history of the site happened in 2015 by digging a lot of deep holes randomly in the area of the tombs to the southeast of the site (Fig 5) (Mohamed Hassan, pers. comm⁴).

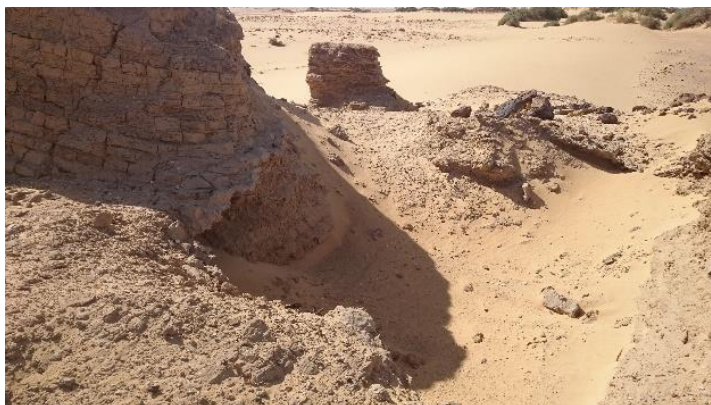
Depending on the interviews with the inspectors of the antiquities in the oasis this site suffered from repeated attacks between 2011 and 2013, especially the southern side where the houses are located (Fig 6). This area is widely damaged by the robbers who destroyed these ancient houses in search of the treasures (Mohamed Ibrahim, pers. comm⁶).

Fig 6. Roman house located to the south of Tulieb fort, has been attacked by the robbers in 2013. Photo by the author (2024)

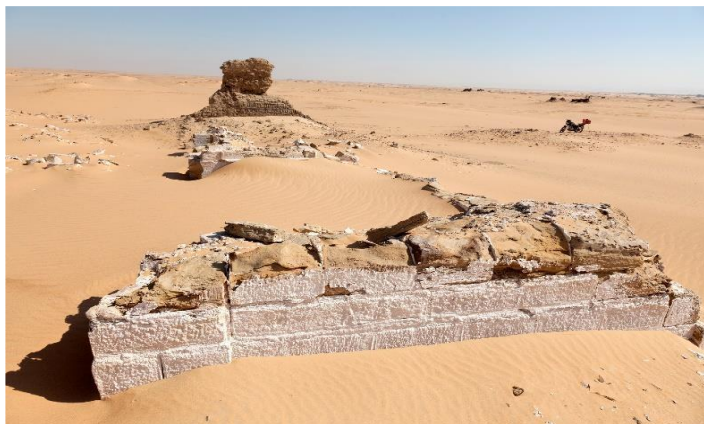
During the nineties of the last century, a group of looters had driven a heavy vehicle through a part of the northern mudbrick enclosure wall. They advanced toward the temple (Fig7) and destroyed the central and western chambers of the sanctuary in search of ancient antiquities⁷. The same thing repeated after the Egyptian revolution in 2012⁸ but this time the violation happened in the area of the necropolis which is located 200 m to the south of the temple (Ikram & Rossi, 2007, p.167).

Fig 7. The destruction of Ain Tarakwa Temple. Photo by the author (2024)

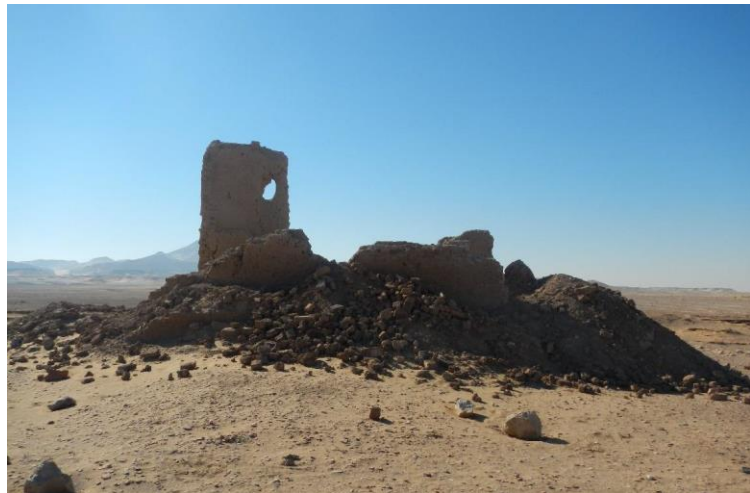
Unfortunately, this site has a long history of destruction since the First World War (1914-1918). The fortress and the surrounding area were used by British troops as a camping place during their fight against the troops of the Sanusi Brotherhood. This is quite clear from modern graffiti engraved on the walls of the fortress (Tallet, 2014, p. 386). Moreover, it was considered as a resting point for travellers over the years. Like the other remote sites in the oasis, which have no fixed guards, most of the tombs in Al Deir had been

Fig 8. One of the domestic buildings in Al Deir has been destroyed on the hands of the looters. Photo by the author (2024)

completely looted and destroyed. In 2000, the French team recorded the exhumation of two mummies out of their tombs by tombs looters in the northern necropolis (Dunand et al., 2012, pp. 15-17). In addition to the acts of vandalism in the northern necropolis recorded by the same French team in 2005, there are proofs of random digging in different places in this area searching for ancient antiquities. These holes have reached to the ceilings of some tombs on the site and damaged them. They also recorded a wooden sarcophagus in one of these holes. It is very likely that this sarcophagus was left by the looters, probably, because they lacked the time to get it out of the tomb. Furthermore, when the French expedition visited the eastern necropolis (dog's necropolis) for the first time in 1996, they found it in a lamentable state; fragments of human and animal bones, textiles, wood, and shard were scattered everywhere in the area. Some tombs (humans and dogs) had been destroyed and looted. At that time, the inspectors of the Antiquities Service decided to collect these fragments randomly and put them again inside the tombs, so it was normal to find the fragments of one object distributed in different tombs. Seemingly, the violation against the site did not stop at that date. During the return of the French expedition to the site in 2001, they found two tombs (E7, E8) destroyed by the bulldozer of the looters (Dunand et al., 2015, pp. 9, 13-14).
